## REDUCTION OF ACCIDENTS BY PAVEMENT GROOVING

Presented at the Western Summer Meeting  
of the Highway Research Board  
Denver, Colorado  
August, 1968

**RESEARCH REPORT**

**NO. M & R 633126**

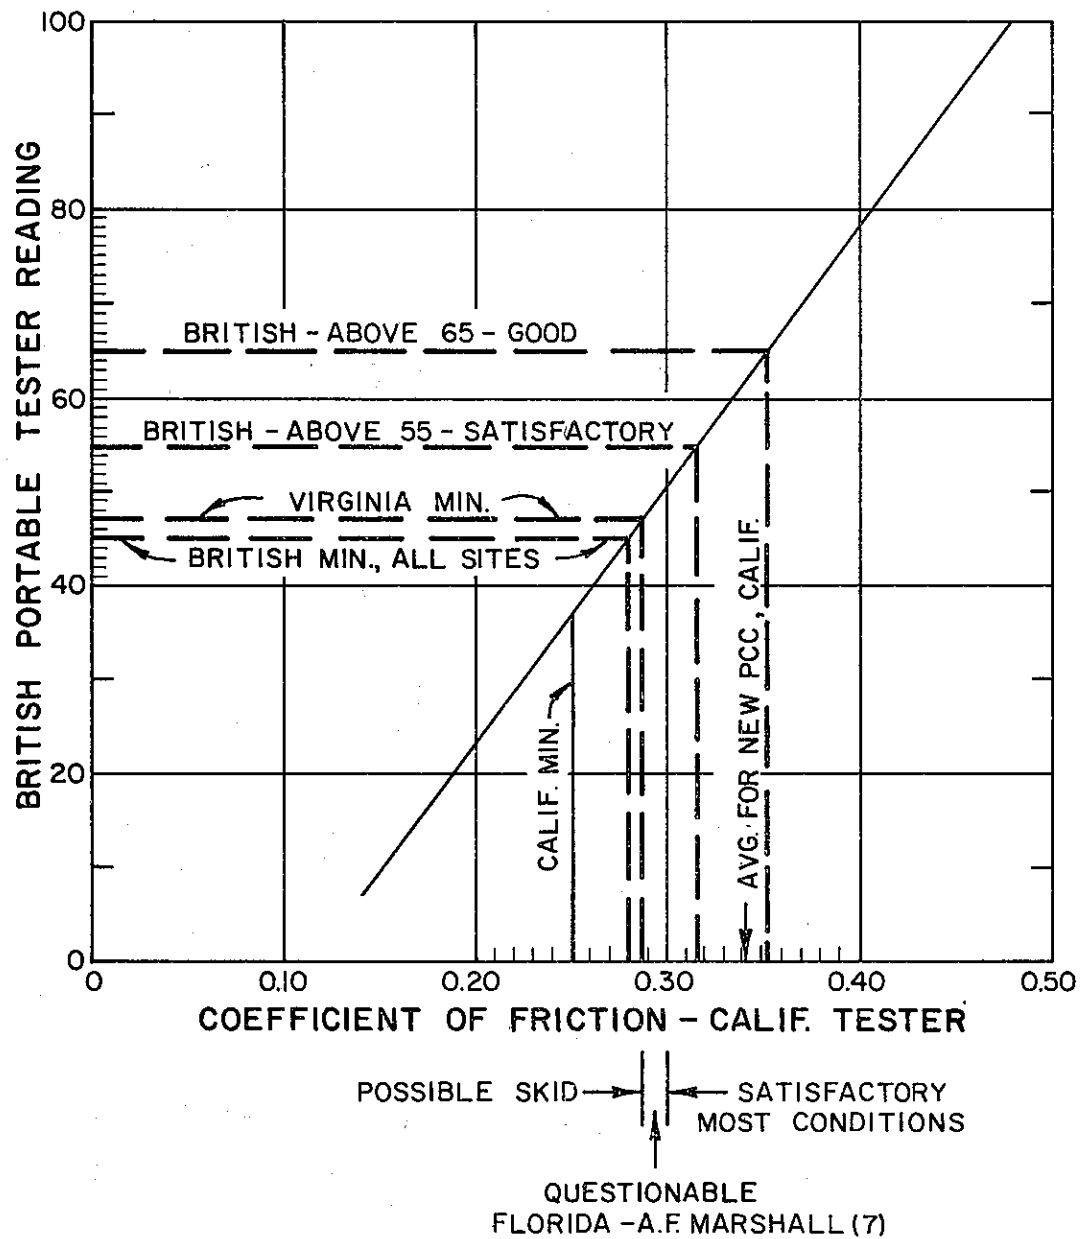
Figure 1

# CORRELATION STUDIES ON MINIMUM FRICTION VALUE FOR REMEDIAL ACTION

On the basis of the correlation, a comparison of the recommended British values with the tentative California minimum figure is shown in Figure 1. Also shown is the Virginia minimum figure which was attained by using the correlation chart of D. C. Mahone<sup>4</sup> which provides an approximate correlation between the British Portable Tester and the Virginia test car at 40 mph.

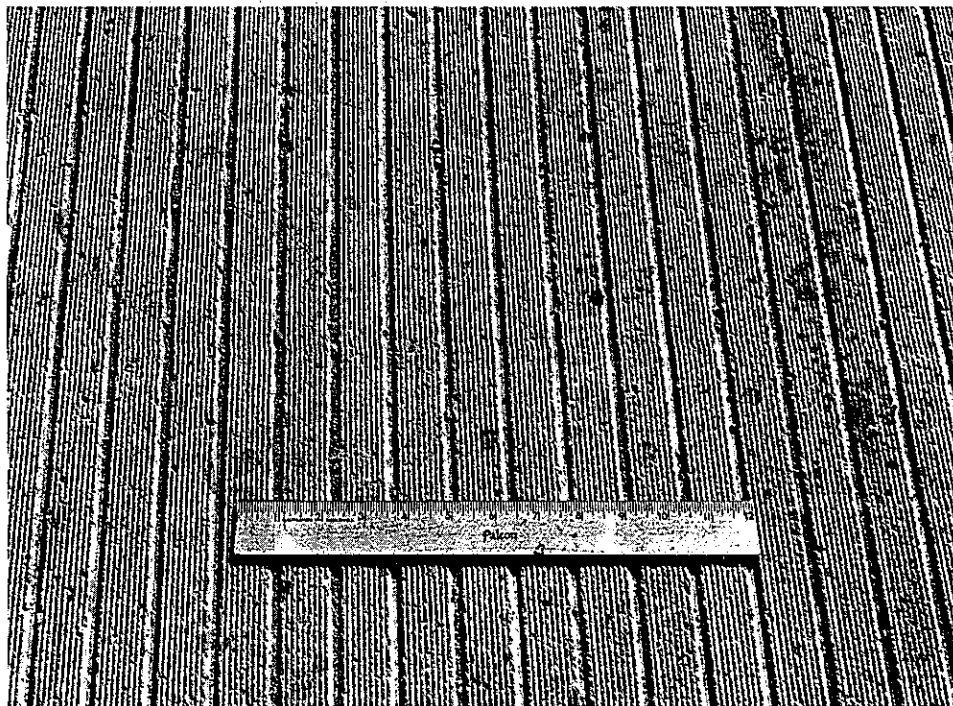
Photographs of Several Patterns Used on Various Projects

Rectangular Grooves

Style 15

Groove patterns vary. The most common type is rectangular in form and may be varied in width and depth and distance between centers of grooves. Other types have rectangular form, but the bottom is partially rounded, and the edges at the pavement surface are also rounded. Others have a large V cut separated by smaller V cuts. Figure 2 shows two types of patterns.

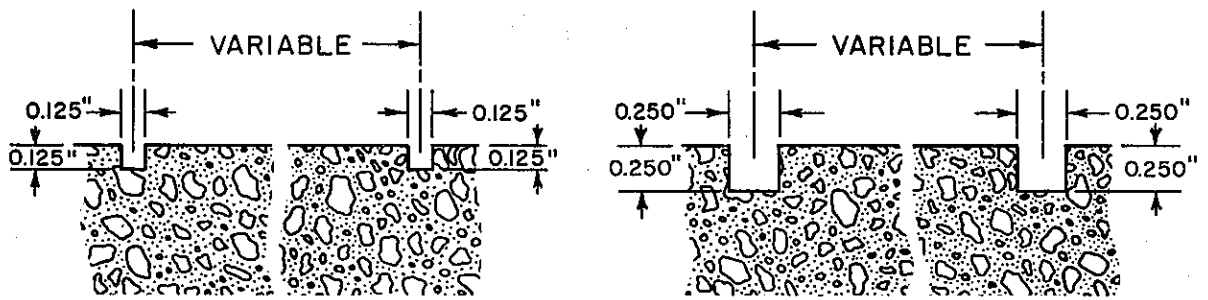
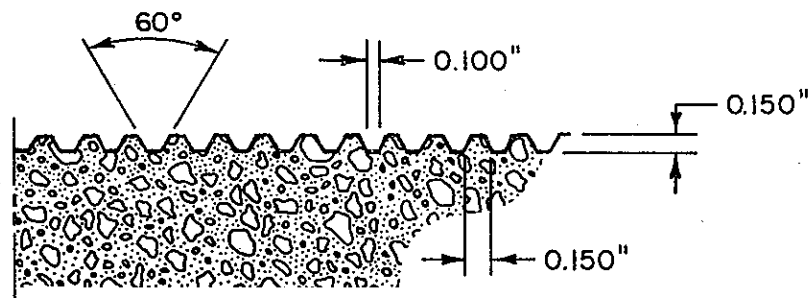
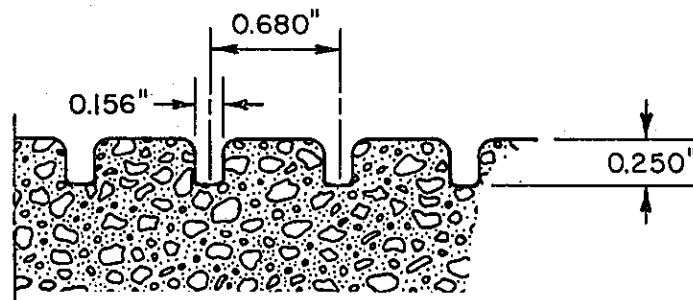
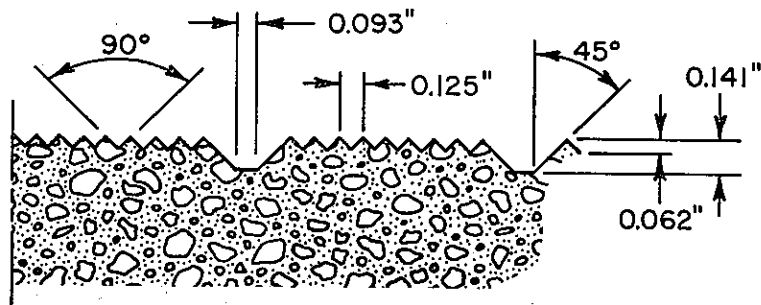
Figure 3

## GROOVING PATTERNS USED ON VARIOUS PROJECTS

### RECTANGULAR PATTERNS

### STYLE 6 - 47 GROOVES PER FT.

### STYLE 9

### STYLE 15

The type of pattern on any specific project effects the degree of improvement. On project K three different Christensen patterns (Table A) were placed in consecutive one hundred foot test sections in the travel lane. The original coefficient of friction values were identical, but two of the patterns produced a very high degree of improvement as compared to the third pattern.

wide on the Placerita Canyon Bridge provided no problems with test motorcycles driven up to 70 mph. There was some vibration up to 50 mph with Style 9, but this tended to fade out at higher speeds. Style 9, see Table A project J, has 3/16" wide rectangular grooves with rounded bottom and edges. These studies indicate that rectangular longitudinal grooves should not be wider than 1/8" in order to prevent possible problems from motorcycles and light passenger cars. However, V cuts do not appear to cause problems although 1/4" wide at the surface.

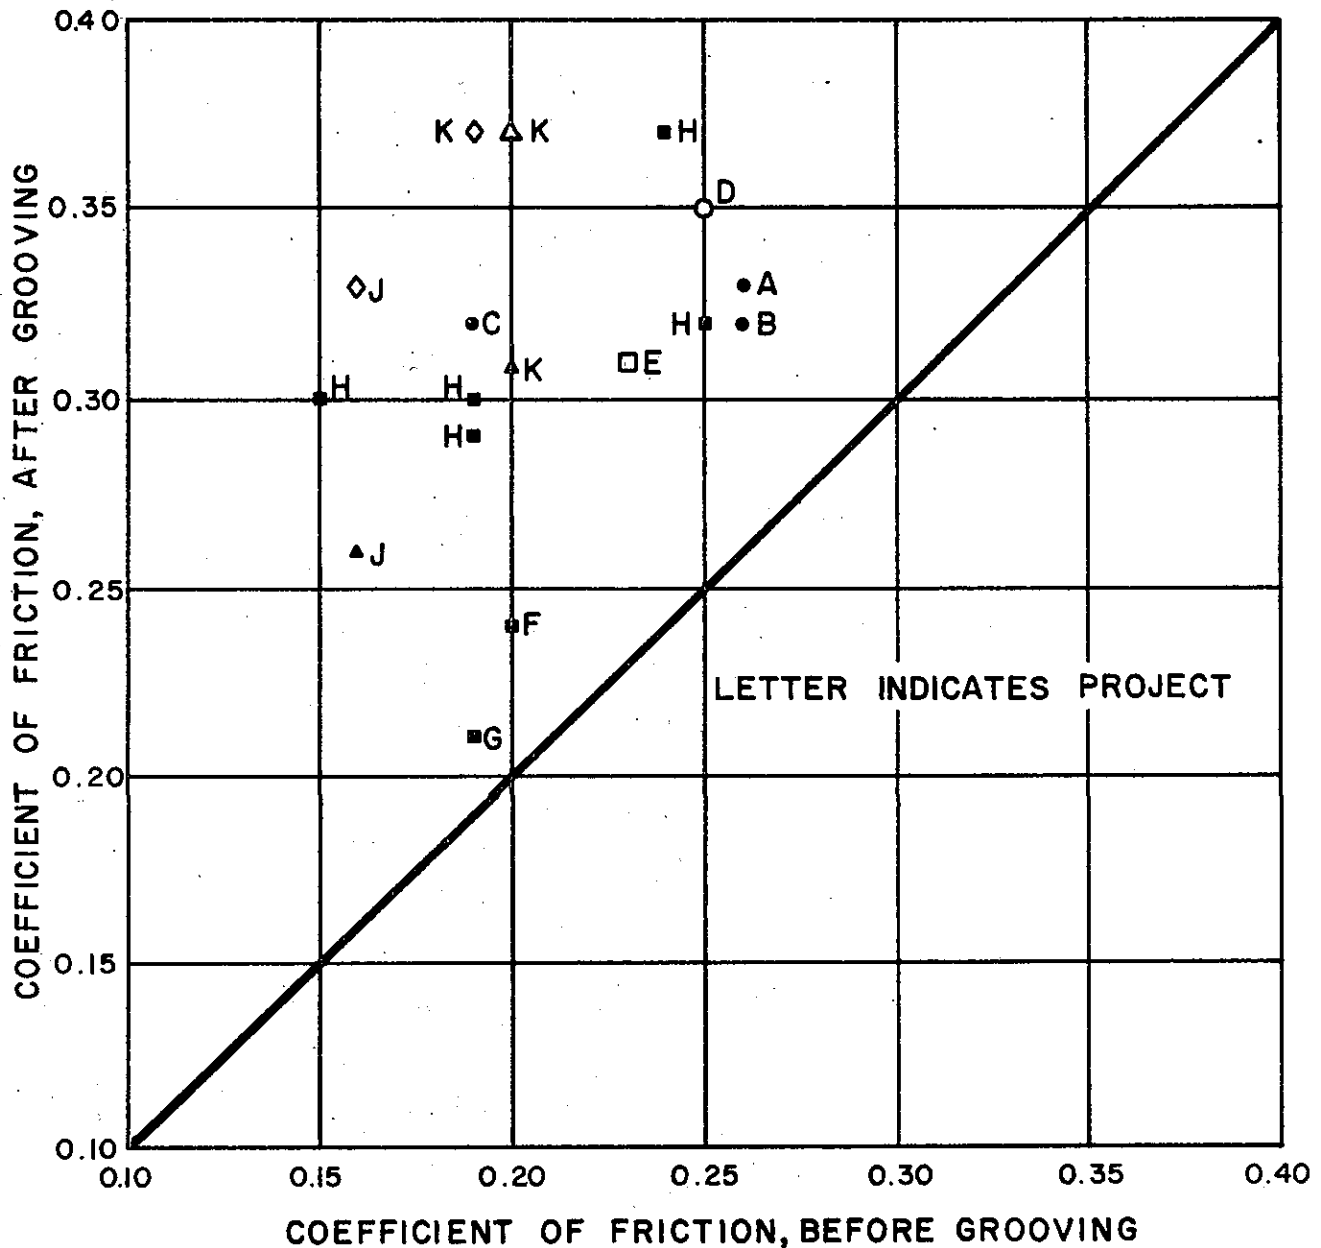
# EFFECT OF GROOVING PATTERN ON AVERAGE COEFFICIENT OF FRICTION VALUE OF PCC PAVEMENTS

- $\frac{1}{8}$ " x  $\frac{1}{8}$ " on  $\frac{1}{8}$ " Centers, Rectangular Grooves
- $\frac{1}{8}$ " x  $\frac{1}{8}$ " on  $\frac{1}{8}$ " Centers, Rectangular Grooves
- $\frac{1}{8}$ " x  $\frac{1}{8}$ " on  $\frac{1}{8}$ " Centers, Rectangular Grooves
- $\frac{1}{8}$ " x  $\frac{1}{8}$ " on 1" Centers, Rectangular Grooves
- △ Christensen Style 6
- ▲ Christensen Style 9
- ◇ Christensen Style 15

A number of patterns have been used in our serration work to date. This was done in order to determine the increase in the friction factor, wear resistance, and possible vehicle handling problem. In all cases the grooves are all in a longitudinal direction. Figure 3 shows the patterns used on the various projects, and Table A the increase in the friction value after grooving and the change during service life. Figure 4 shows the effect of grooving on the average coefficient of friction value for the various PCC pavement projects.

In all cases the friction value is raised by pavement grooving. However, it appears that the nature of the existing concrete surface and the type of pattern effect the degree of improvement in the friction value. As an example there is a much greater improvement in the friction value for project H than on projects F and G for a  $1/8" \times 1/8"$  on 1" centers with a rectangular groove. This is also confirmed by the results from projects J and K where two different patterns are compared on two different projects.

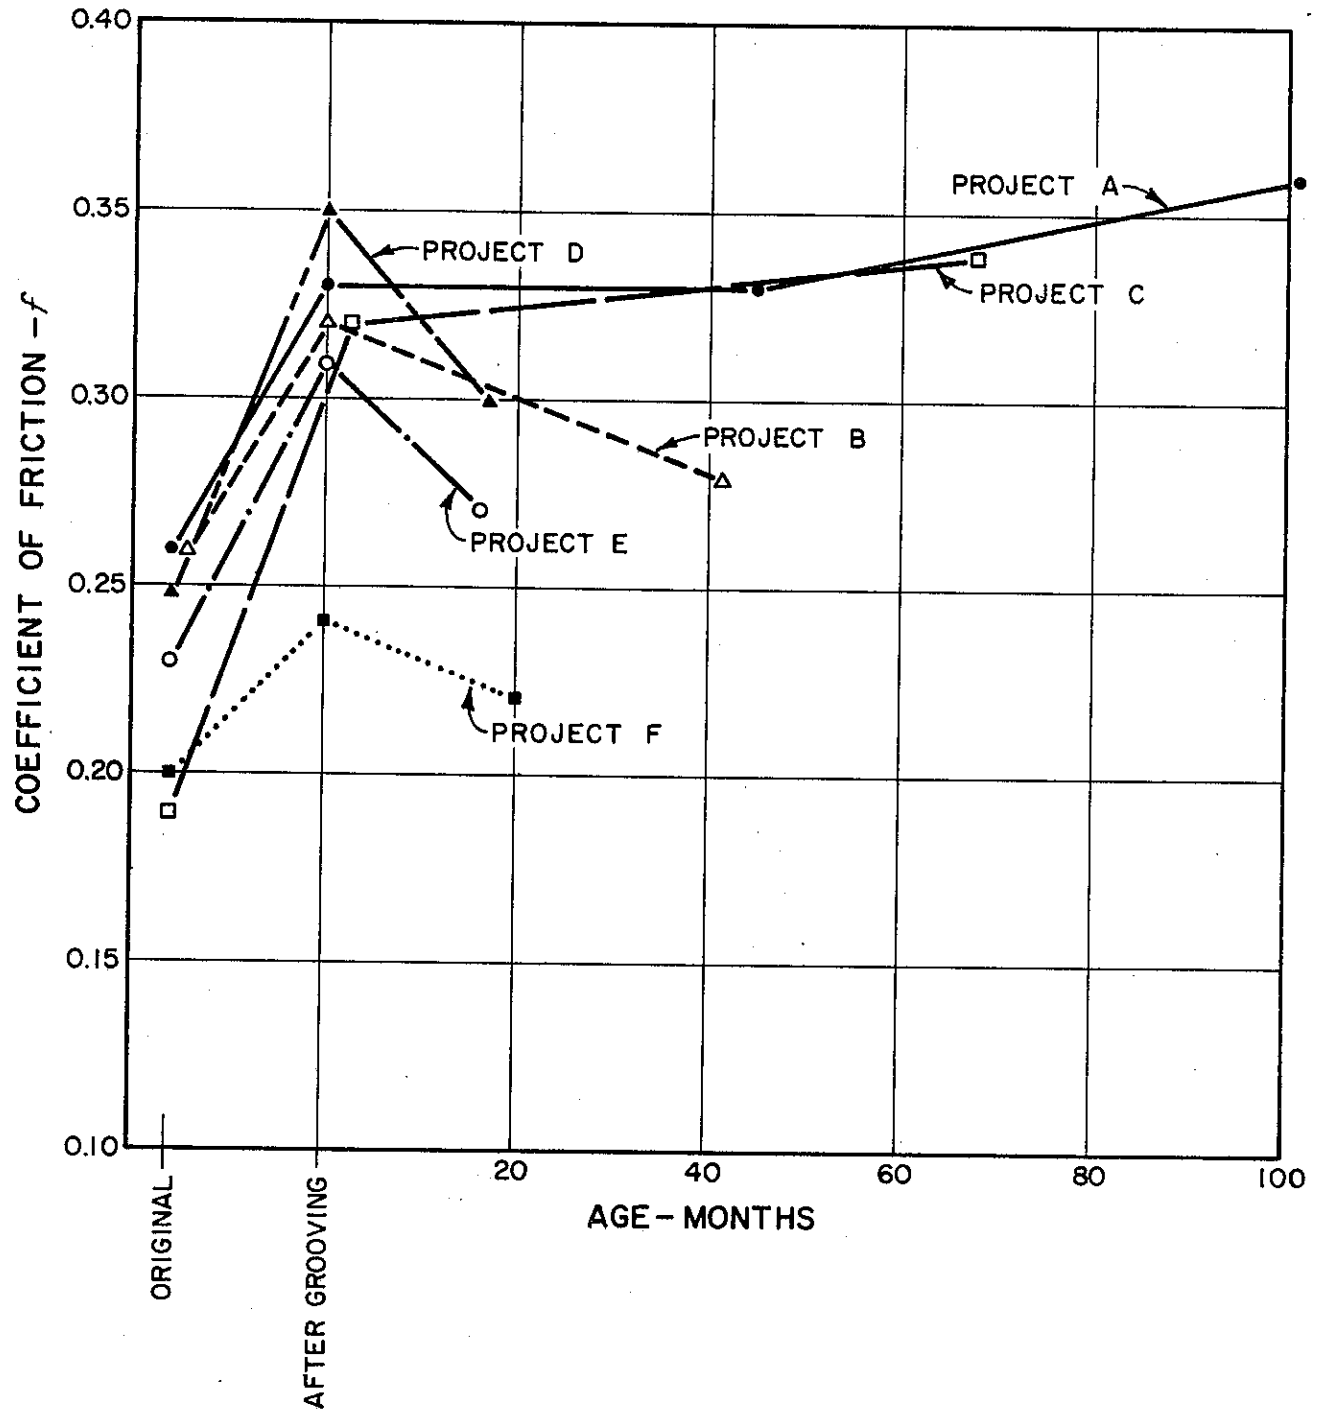
# CHANGE IN FRICTION VALUES FOLLOWING GROOVING OF PCC PAVEMENTS

A very important characteristic of any treatment for raising the existing friction value is its resistance to wear and polish of traffic. Results of variations of friction measurements with time on various grooved projects are shown in Table A and Figure 5. Not sufficient time has elapsed on the majority of the projects to draw any firm conclusions. It appears, however, that the nature of aggregate and mortar strength may influence the resistance to wear and polish of the grooved areas. However, it is interesting to note that projects A and B cover the travel lanes of heavily travelled freeways having a high percentage of trucks. All the projects shown in Figure 5 are in snow free areas. Project H in Table A is in a partial snow region where chains may be required. After the first winter the surface does not appear to be damaged by chain action. This project will be closely watched since project M in Table B has shown considerable

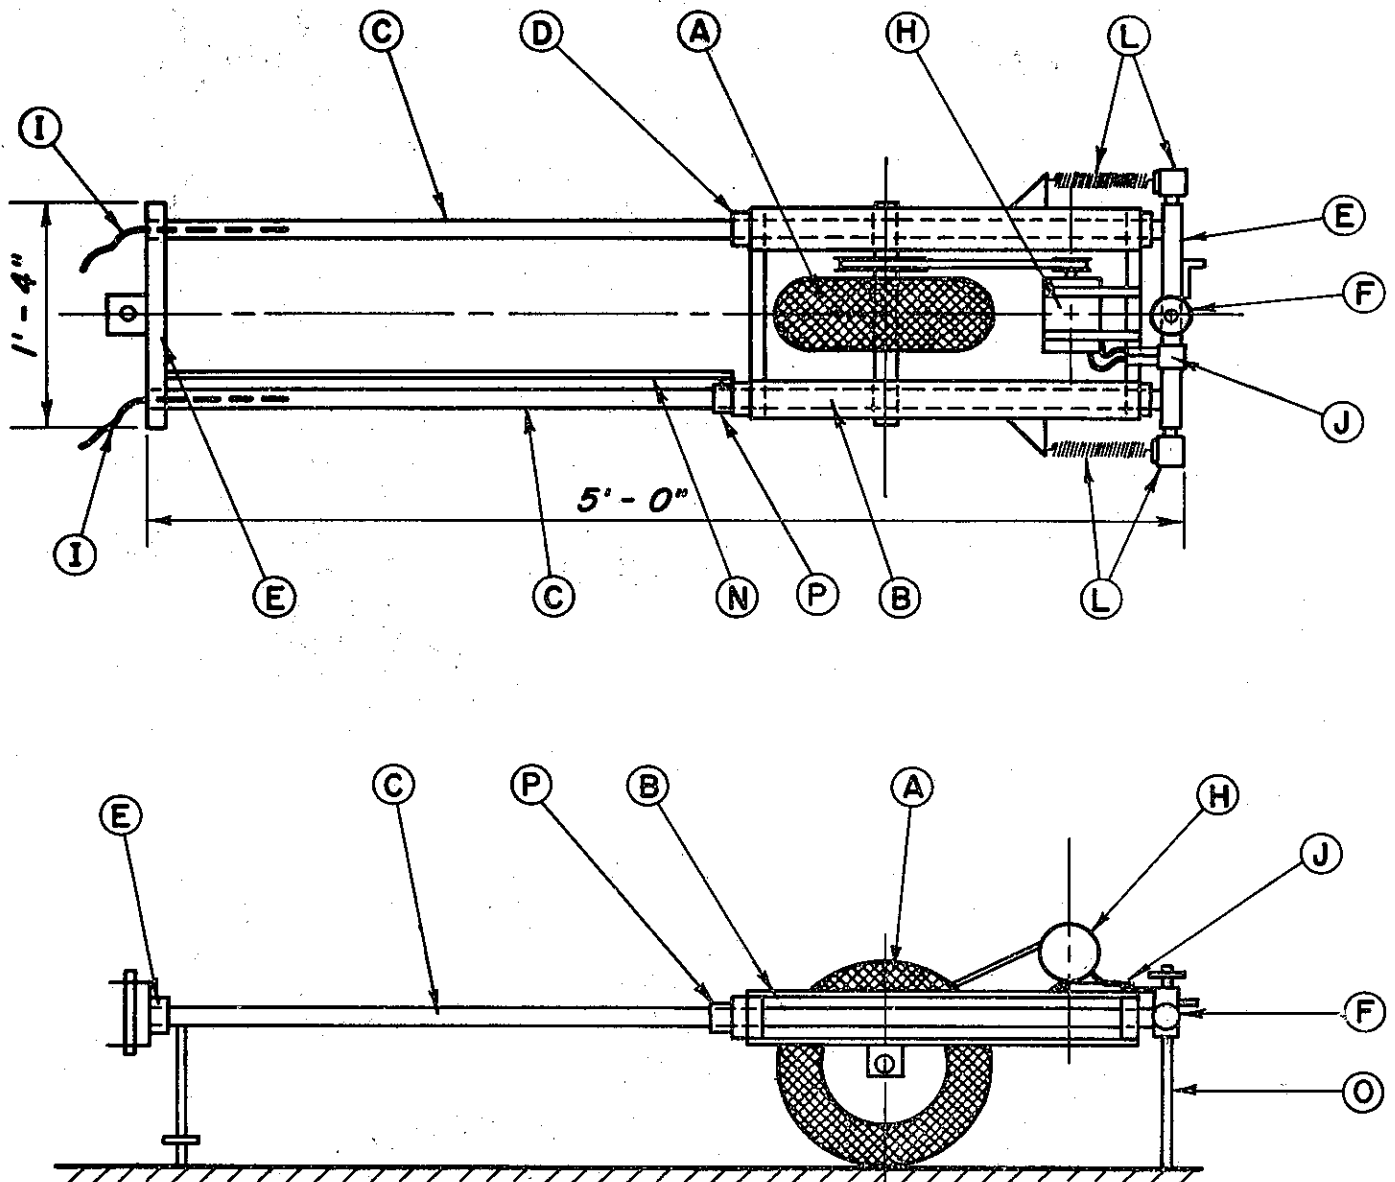
FIGURE 1  
DIAGRAM OF SKID TESTER

a. Reference is made to Figures I through III in connection with the following description of the construction of the test unit. A 4.80/4.00 x 8, 2-ply tire with  $(25 \pm 2)$  psi air pressure ( $\Delta$ ), manufactured with a smooth surface, together with rim, axle and driving pulley is mounted on a carriage (B). The tire is brought to desired speed by motor (H). The carriage moves on two parallel guides (C), and the friction is reduced to a low uniform value by allowing three roller bearings fitted at 120° points to bear against the guide rod at each corner of the carriage. The bearing assembly may be noted on Figure III (D). The two guide rods (C) are rigidly connected to the end frame bars (E). The front end of this guide bar frame assembly is firmly fastened to a restraining anchor. The bumper hitch provides for swinging the skid tester to the right or left after positioning the vehicle. The rear end of the frame assembly is raised by a special adjustable device (F), Figure II, so as to hold the tire  $\frac{1}{4}$ -inch off the surface to be tested. This device is so constructed that the tire may be dropped instantaneously to the test surface by tripping the release arm (G), Figure II. Tachometer (K) indicates the speed of the tire.

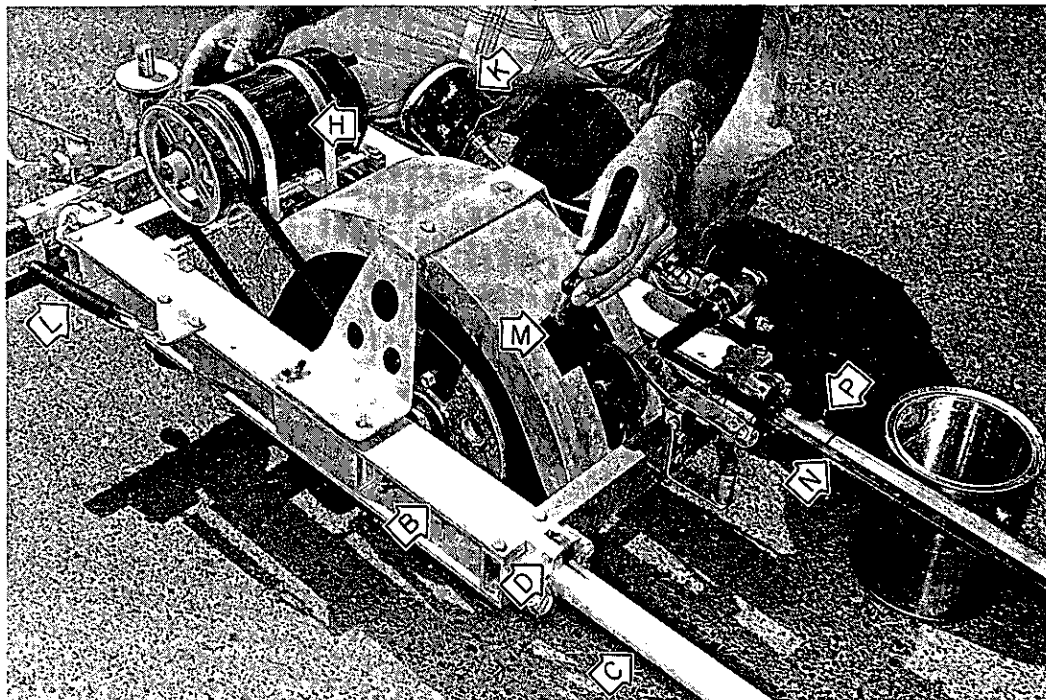
FIGURE III  
CLOSE-UP VIEWS OF SKID TESTER

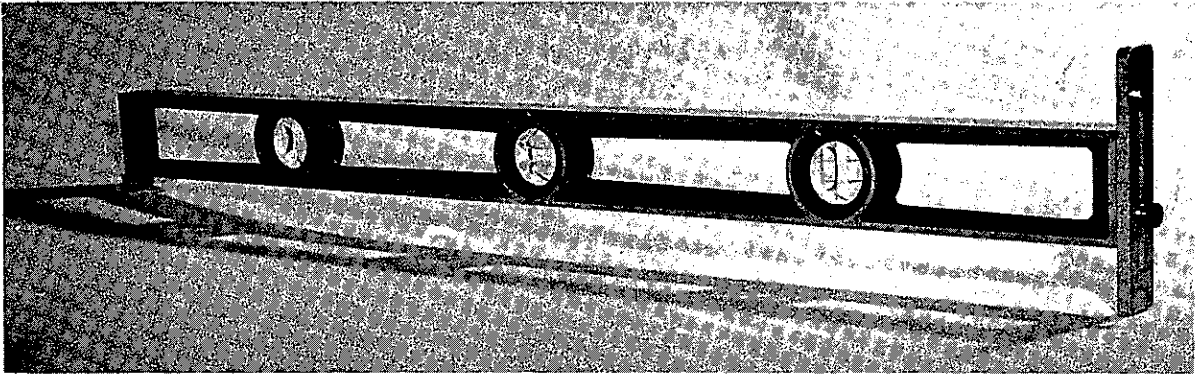
FIGURE IV  
LEVEL FOR DETERMINING GRADE

a. A 28" long standard metal carpenter's level, Fig. IV, is fitted at one end with a movable gauge rod which is calibrated in % of grade.

1. Determine and record grade with special level, see Fig. IV.

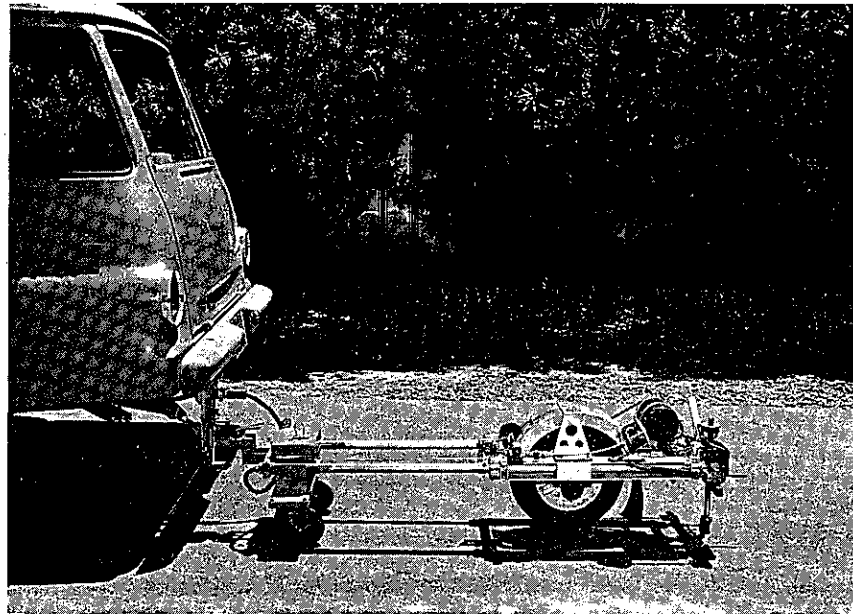
FIGURE V  
APPARATUS IN POSITION FOR TESTING

2. Remove apparatus from vehicle and attach to bumper hitch, Fig. V.

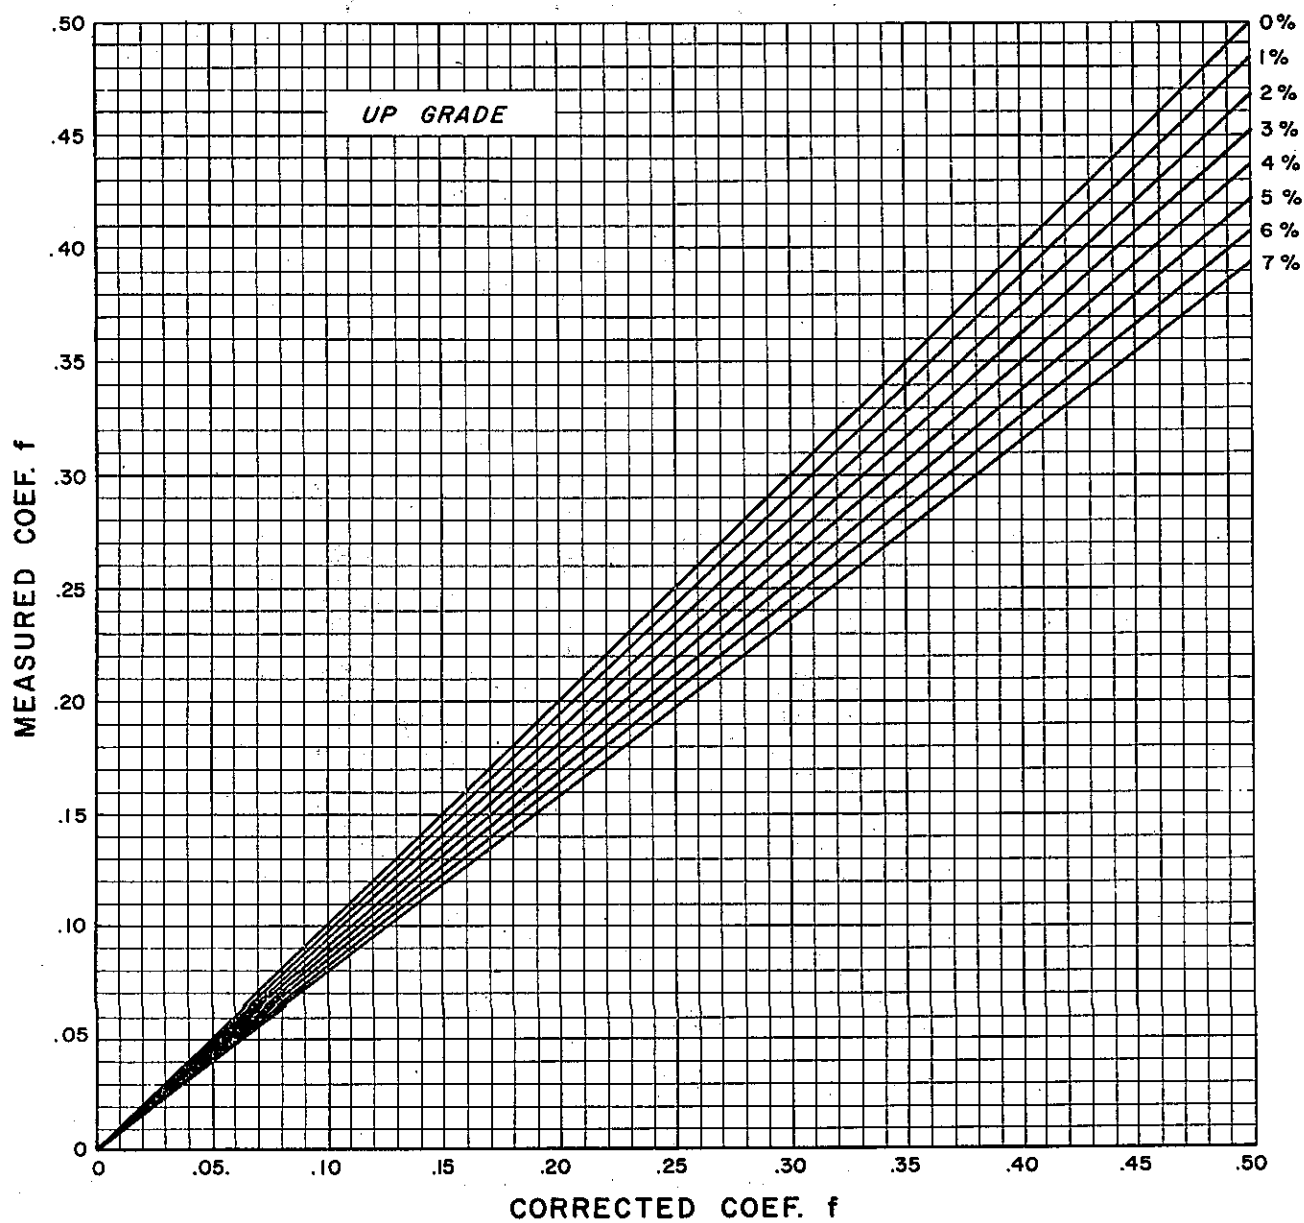
FIGURE VI

**COEFFICIENT OF FRICTION CORRECTION CHART**  
**FOR MEASUREMENTS MADE ON GRADES**

1. Make grade corrections using charts shown in Figures VI and VII.

\* Corrected coefficients of friction were taken from chart in Figure VI.

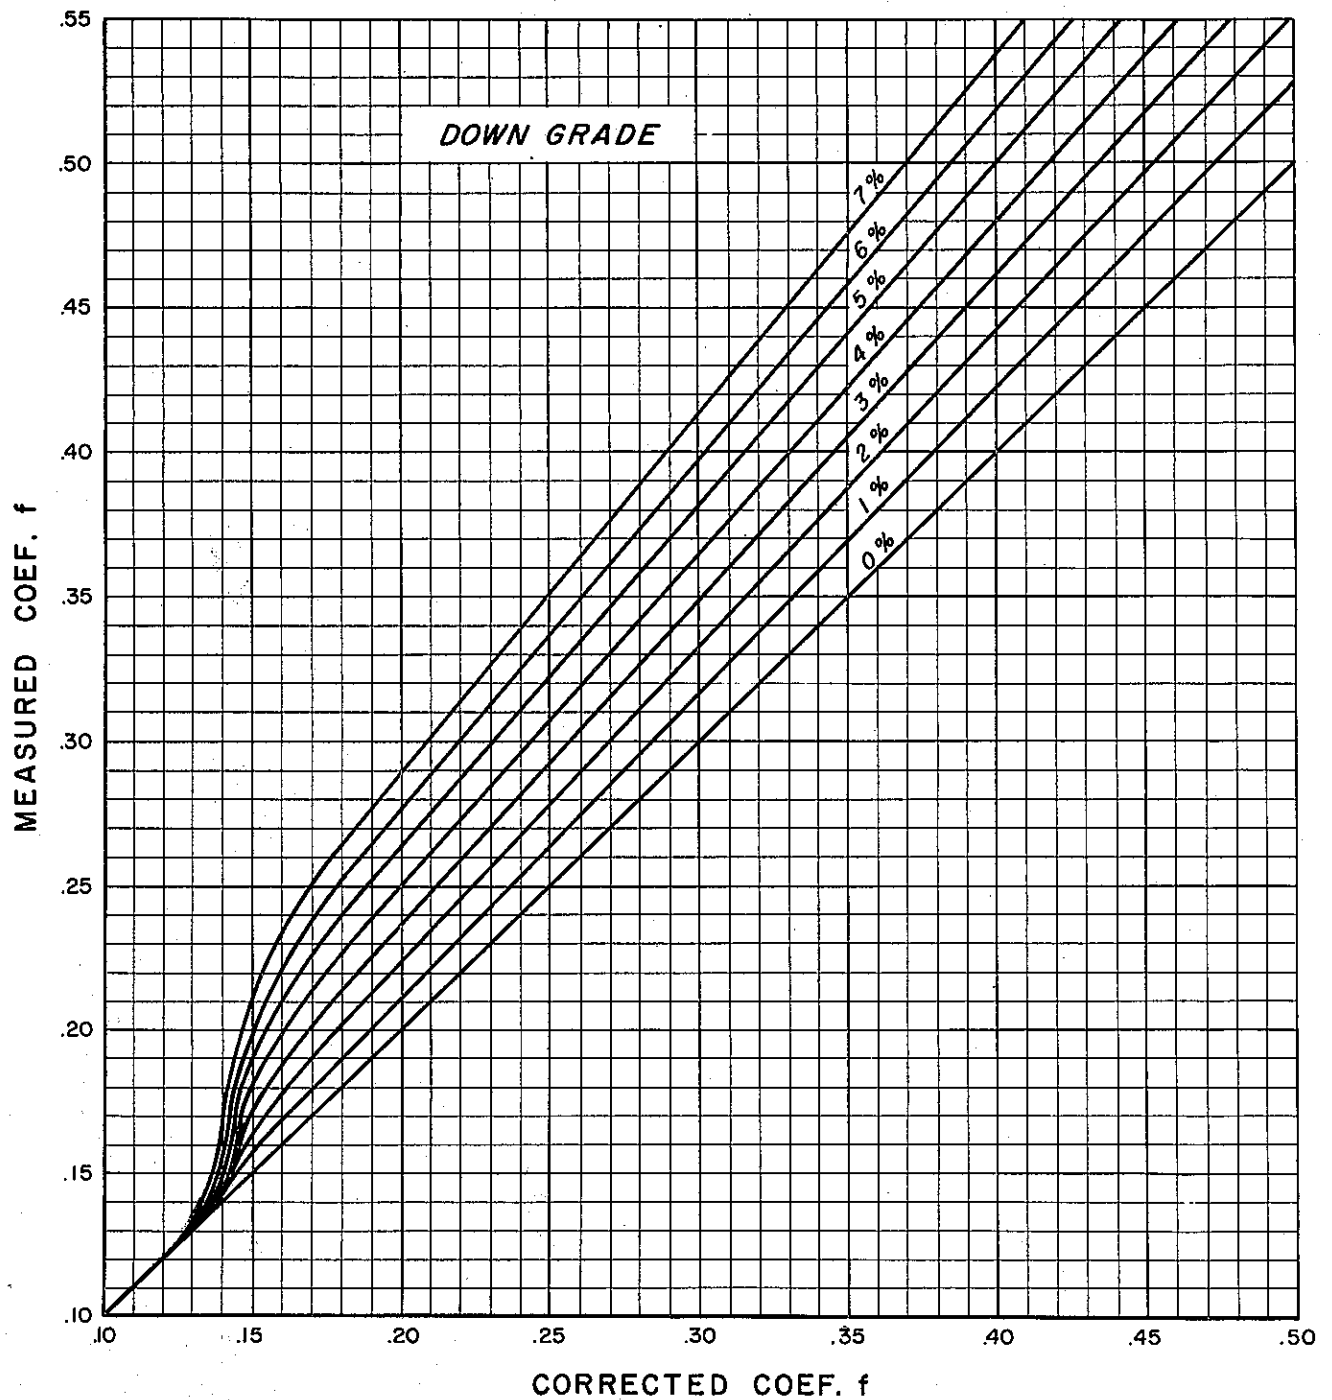
FIGURE VII

COEFFICIENT OF FRICTION CORRECTION CHART  
FOR MEASUREMENTS MADE ON GRADES

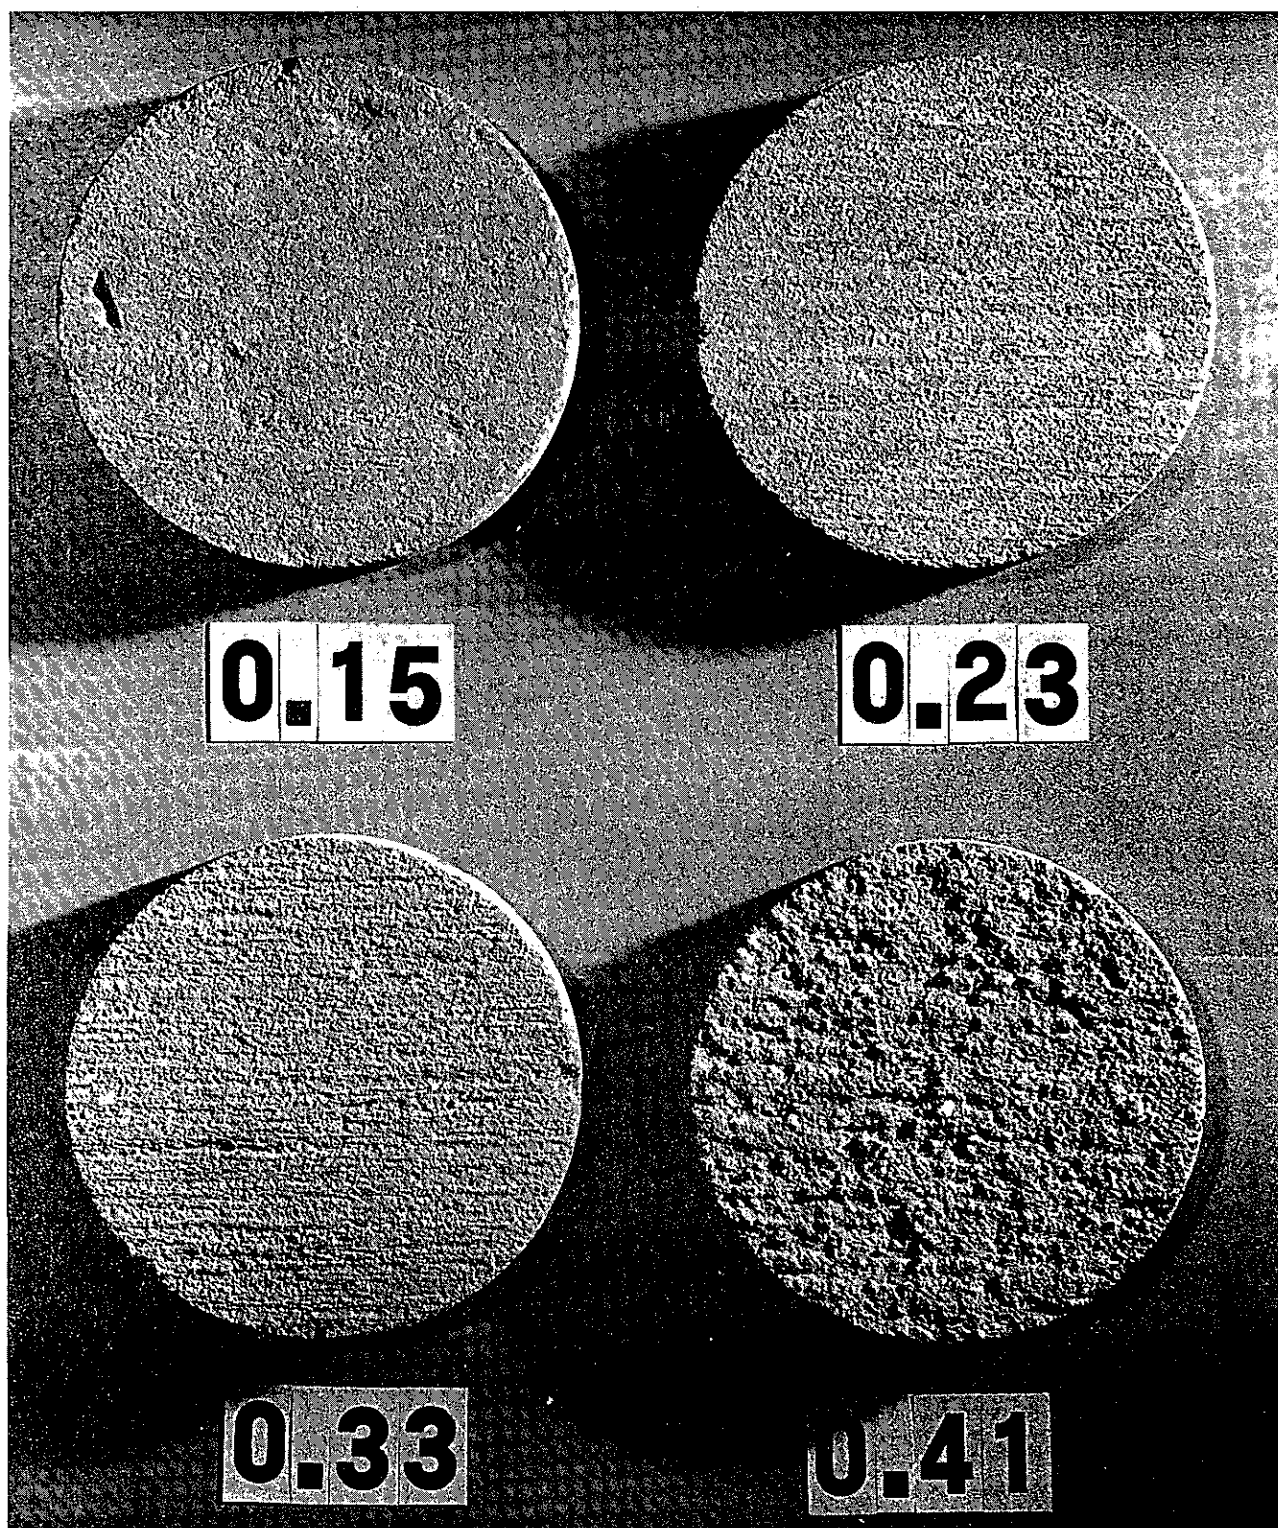
FIGURE VIII  
PHOTOS OF SURFACE TEXTURES

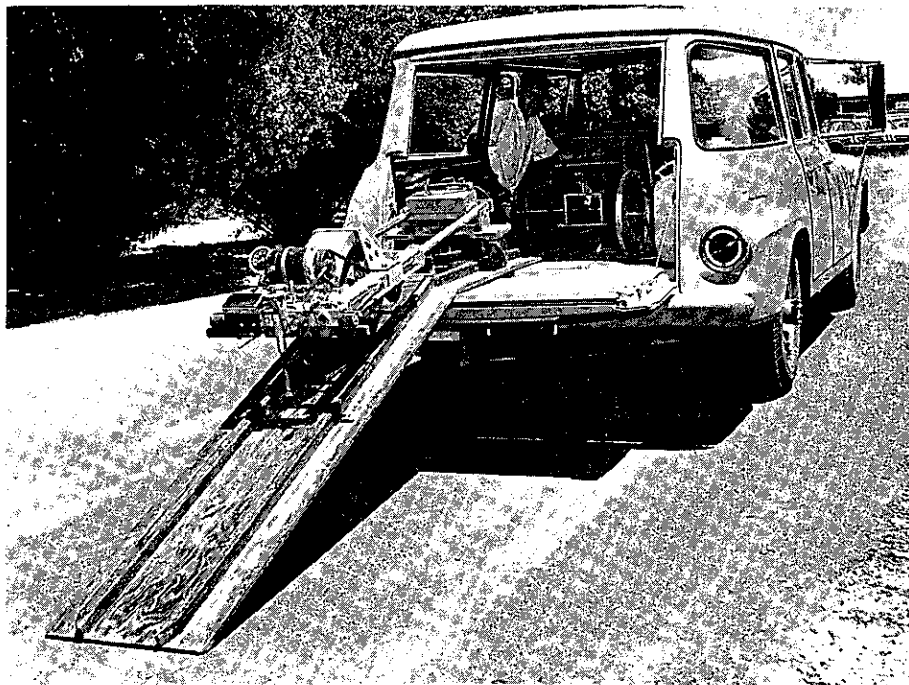
FIGURE IX  
APPARATUS BEING PLACED IN VEHICLE  
NOTE CABLE AND WINCH FOR MOVING SKID TESTER

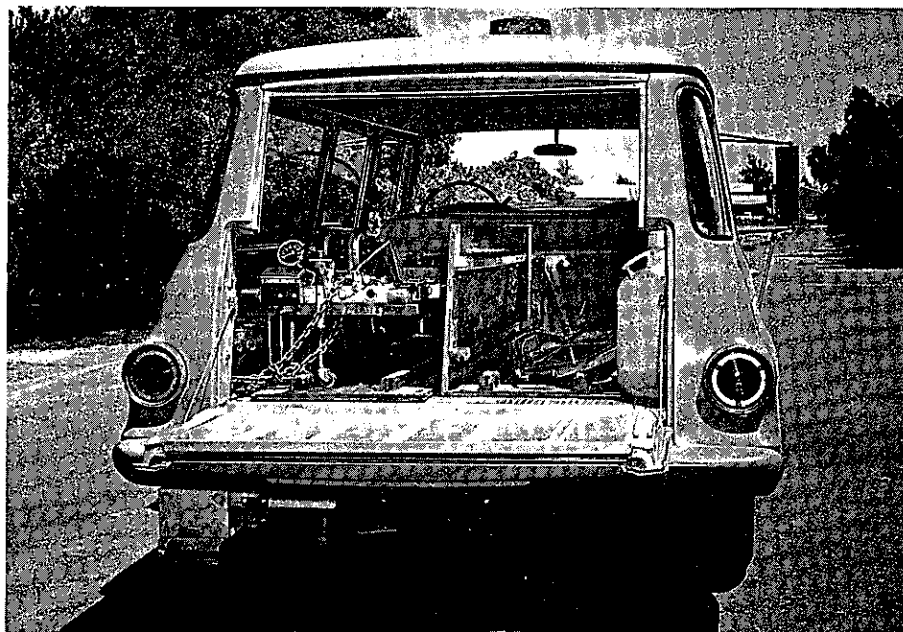
FIGURE X  
APPARATUS IN POSITION FOR TRANSPORTATION
